Maryland Historical Trust HISTORIC PROPERTIES

State Historic Sites Inventory Form

Survey No. B-4383

2. Locati	on	tou a no wash	at emblint your	e-ostid yed
street & number	203 W. Sar	atoga Street	d deside e men	_ not for publication
city, town	Baltimore	vicinity of	congressional district	Seventh
state	Maryland	county	Baltimore	. A mail saidt

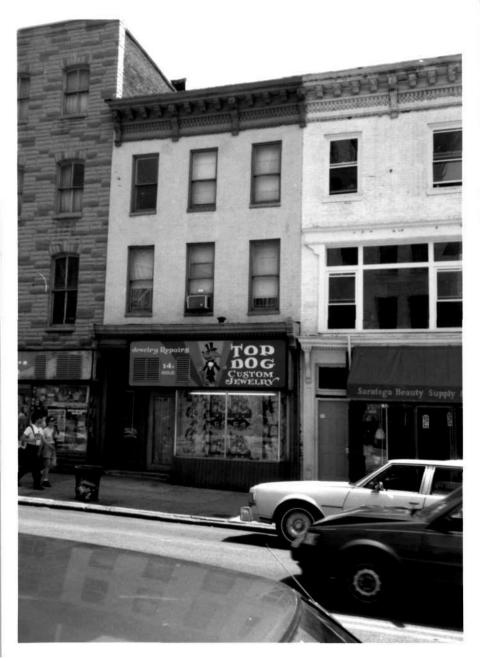
B-4383
203 W. Saratoga St.
Baltimore MD
Diane Shaw
8/91
Maryland SHPO
Facade, north elevation
1/2

This circa 1875 shed-roofed commercial building faces north on W. Saratoga Street and abuts two partywall buildings. The three-bay, three-story building is part of a brick commercial block. This independent section, defined by seams in the brick work and fenestration, has a street frontage of 18' and a depth of 50'.

The first story has been altered. To the east is a white and rust tiled recessed vestibule containing two doors. There is an original door with a glass panel above and two wood panels below. A mail slot with ornamental shelf is cut into wood pane. The transom is now blocked. transom bar has a dentil row. pilaster runs up the east side, a plain board runs up the west side. A second glass door with wood surrounds abuts the board. The remainder of the facade is an angled display window. The first plate of glass angles out toward the street; the second plate is flush with the plane of the facade. The window is set above a foundation of wood panelling. A projecting cornice runs across the The profile consists of fillet, ogee, bead, back first story. band, dentil course, ogee and fillets. It is flanked by scrolled brackets at either end; the bracket to the west has rosette crest. The area above the first story is covered by a plastic boxed sign.

The second and third stories have three 1/1 sash windows with

wood sills and brick splayed jack arches.

The wood cornice is very elaborate. It has molding with a fillet, ogee, fillet, and back band profile projecting over a row of scrolled brackets with fine details. A row of raised molding and two rows of corbelled jig-sawn and drilled leaf molding run below. A brick band terminates the bottom of the cornice. Large brackets bisect the cornice into two bays. The bold, scrolled brackets have applied rosettes on the projecting arms.

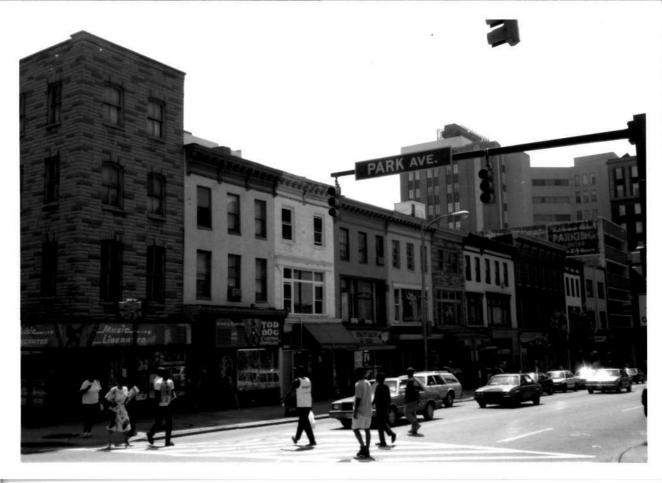
B-4383
201-227 W. Saratoga (block)
Balhmore mD
Diane Shaw
8/91
Manyland SHPO
Block of 201-227 W Saratoga, north Side
2/2

This three-bay, three-story building is a simple example of speculative commercial block construction along Saratoga Street during the third quarter of the nineteenth century. It is partnered with a matching mate, but the two units are separated by a brick seam indicating separate stages of construction, and have separate entrances and separate alterations to the buildings. The building's style and massing are representative of the late nineteenth-century rowhouses and partywall structures on the block. A few elements of Victorian fashion are still visible. The first story has been altered, but the nineteenth-century stringcoursecornice remains in place. The first-story cornice was a common feature to commercial buildings in the nineteenth century and often served to demarcate the commercial from the residential zones. The first story would have been used for sales or display area and the upper stories would have been used as dwellings. The upper stories are sparely treated, with brick lintels and stone sills. cornice (which it shares with its row neighbor) is Italianate: overhanging eaves are supported by small modillion brackets and bay-defining scrolled brackets, a common way of decoratively capping the top of a building.
